Confidential Inspection Report 123 Anywhere Ave Kansas City, MO 64133

October, 2015

Prepared for: Tom Thumb

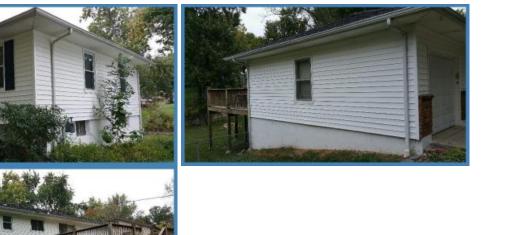
Walls are constructed with VinvI siding and Brick. Cracks minor noted. Seal as needed.

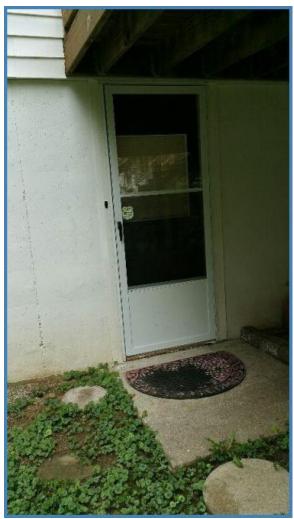
Wood, panel type door, with glass. **Observations-** Weather-stripping is only fair and needs renewal. Gaps are noted.

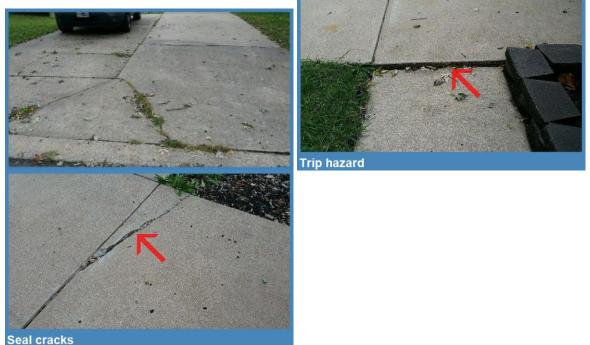
Concrete, Observations- Surface raised/settled, Portions missing, Tripping hazards.

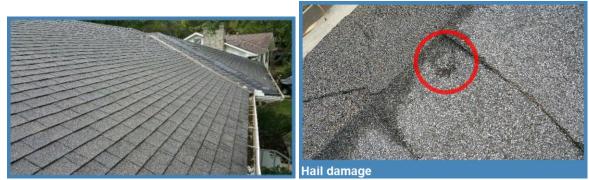
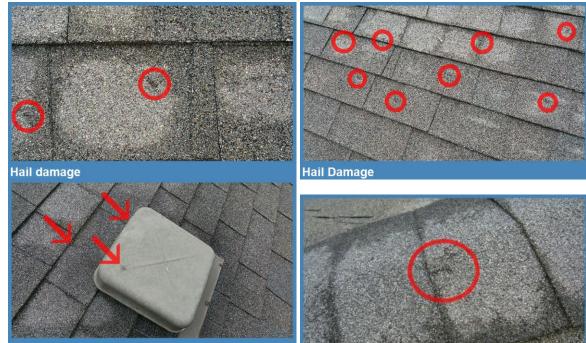
Hail Damage noted to roof surface. Consult qualified roofing contractor to evaluate and repair as needed.

Hail dents in roof vents Flashings:

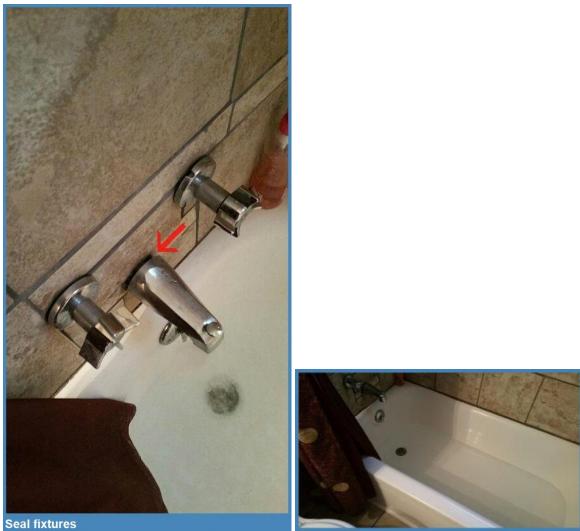
Tub drains slow, Seal fixture to wall.

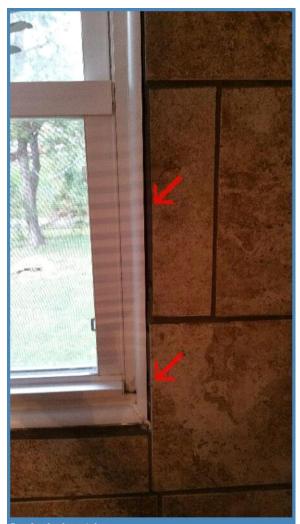
Shower walls appear serviceable, Caulk and seal all tub and shower areas as a precaution.

Seal window trim Bath 2 :

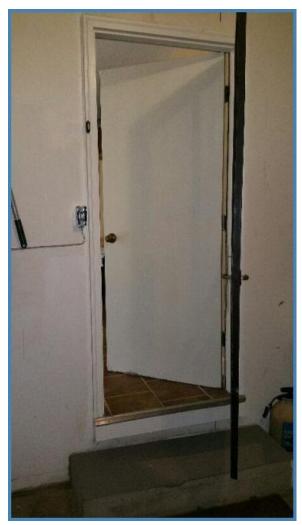
Worn weather strip. Repair as needed. No fire rated door. Fire rated doors are recommended for house to garage doors.

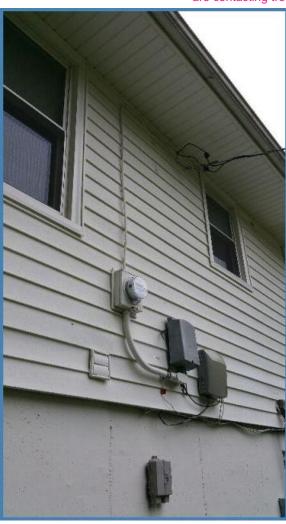
Overhead, 110/220 Volt, Circuit breakers. Damage/Defects noted: Overhead conductors are contacting tree limbs. Have the power company trim as needed.

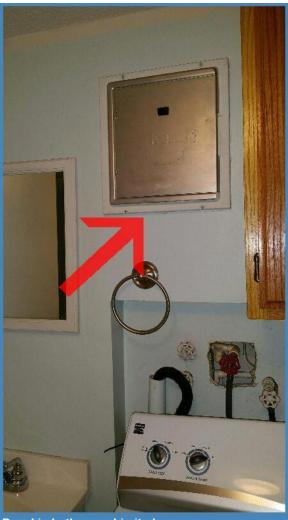
Bathroom. Electrical panel is in the bath room this is not allowed per current building practices. Shock and corrosion hazard noted.

Panel in bathroom. Limited access Main Circuit Rating: 100 amps.

Damage/defects noted, Multiple wires are connected to a single lug on a circuit breaker where only one wire should be connected. Clearance its limited. Clearance requirements for panel is 36"in front and 30"width.

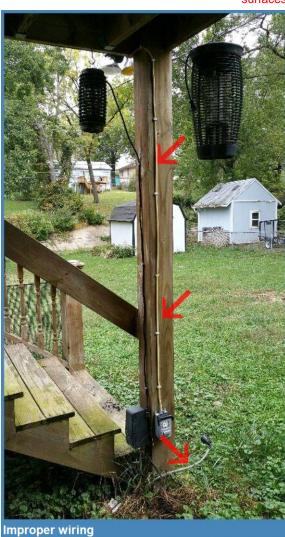
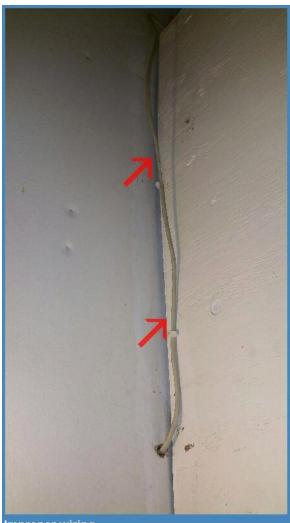
Unsafe conditions exist, Contact a licensed electrical contractor to evaluate, price and repair wiring as needed. Romex wire run on wall surface. This wire is to be protected by a conduit on all wall surfaces.

Romex wire run on wall surface. This wire is to be protected by a conduit on all wall surfaces.

Improper wiring Switches & Fixtures: General:

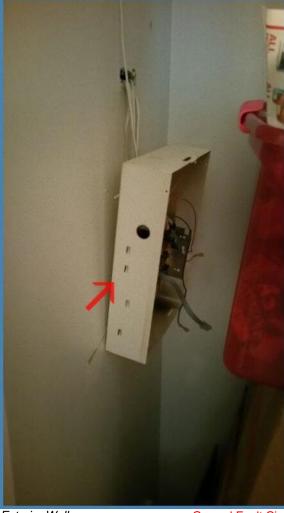
A representative sampling of outlets was tested. As a whole, outlets throughout the home are in serviceable condition. Alarm cabinet is falling off wall. Repair as needed.

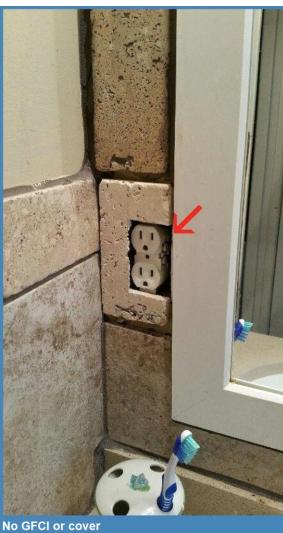
improper wiring Master Bath:

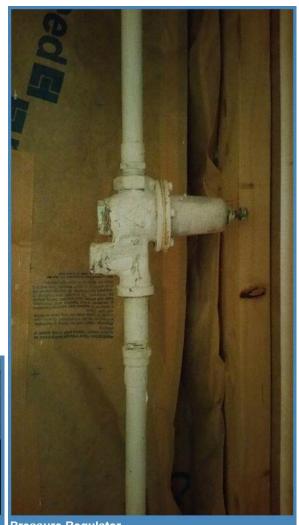
Pressure Regulator

The water pressure is over 100 psi. Water pressure this high can cause damage to fill valves in toilets, dishwasher, and clothes washer. A water pressure regulator valve should be installed to regulate the pressure to an acceptable 40 to 80 psi range. There is a water pressure regulator valve correctly installed. This allows adjustment of the incoming water pressure.
