Confidential Inspection Report 123 Anywhere Ave Kansas City, MO 64133

October, 2015

Prepared for: Tom Thumb

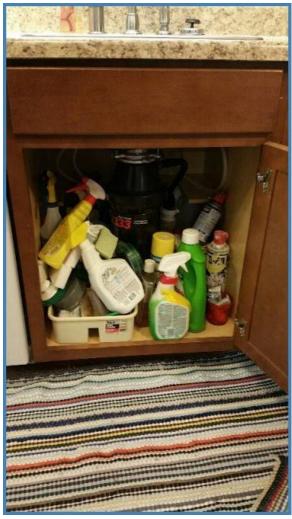
Flex drain line Sink Cabinet:

View was blocked by stored items.

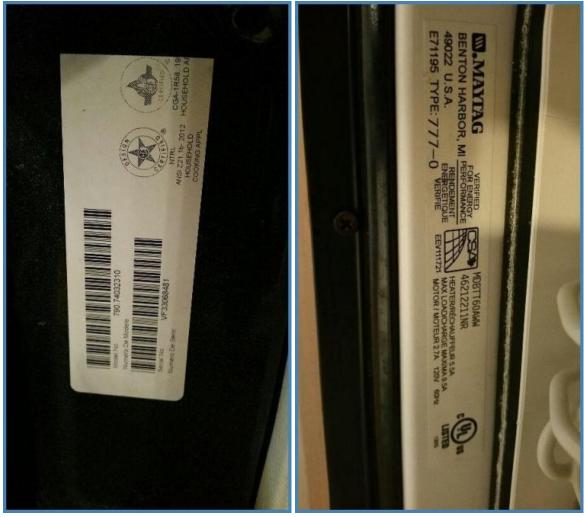
Range/ Cooktop / Oven:Type & Condition:Gas, App

Gas, Appears serviceable.

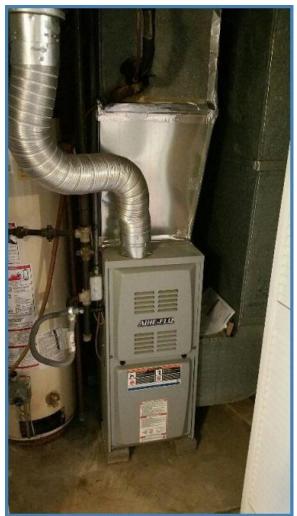
Type & Location:

Forced Air. The furnace is a modern high efficiency type with a fan installed in the vent pipe to push the burnt flue gases up and out the flue. Location- Basement, Closet, Access to this equipment is restricted.

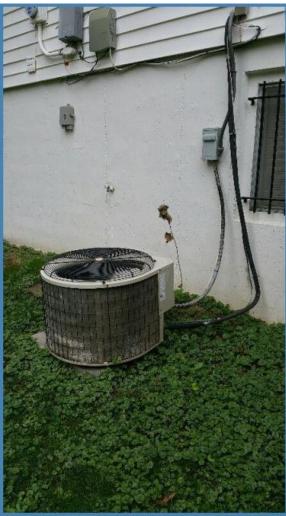
Primary Type:

Central, Split System- Electric, Outside air temperature was below 65 degrees. Unable to test system at this time.

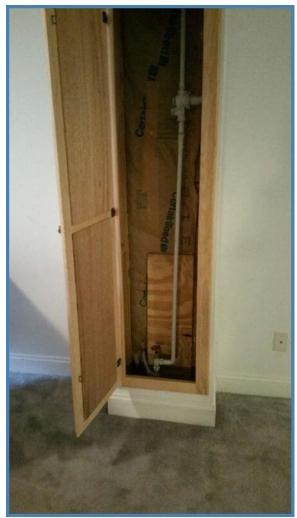
Main Line: Shut Off:

Main shutoff valve is located basement.

The water pressure is over 100 psi. Water pressure this high can cause damage to fill valves in toilets, dishwasher, and clothes washer. A water pressure regulator valve should be installed to regulate the pressure to an acceptable 40 to 80 psi range. There is a water pressure regulator valve correctly installed. This allows adjustment of the incoming water pressure.

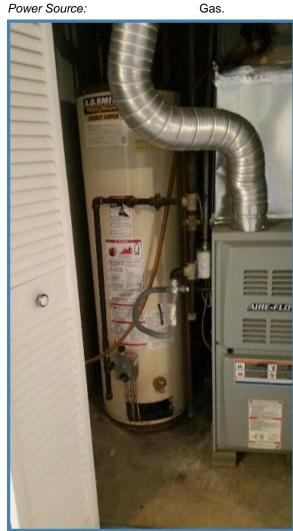
Water Heater:

The temperature pressure relief valve at the upper portion of the water heater is a required safety valve which should be connected to a drain line of proper size terminating just above floor elevation. If no drain is located in the floor a catch pan should be installed with a drain extending to a safe location. The steam caused by a blow-off can cause scalding. Improper installations should be corrected.

30 Gallons, 1993 model.

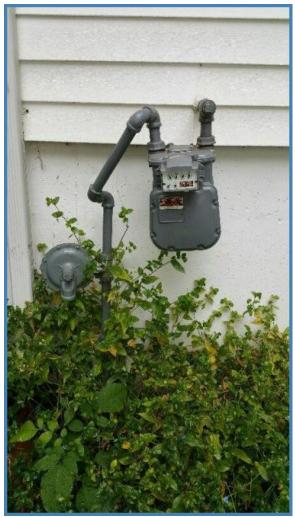
Meter / Tank:

Meter is located at the exterior, at the side of the house, System appears serviceable.
